Special Board of Education Meeting Regarding the Condition at Lum Elementary School

April 28, 2017

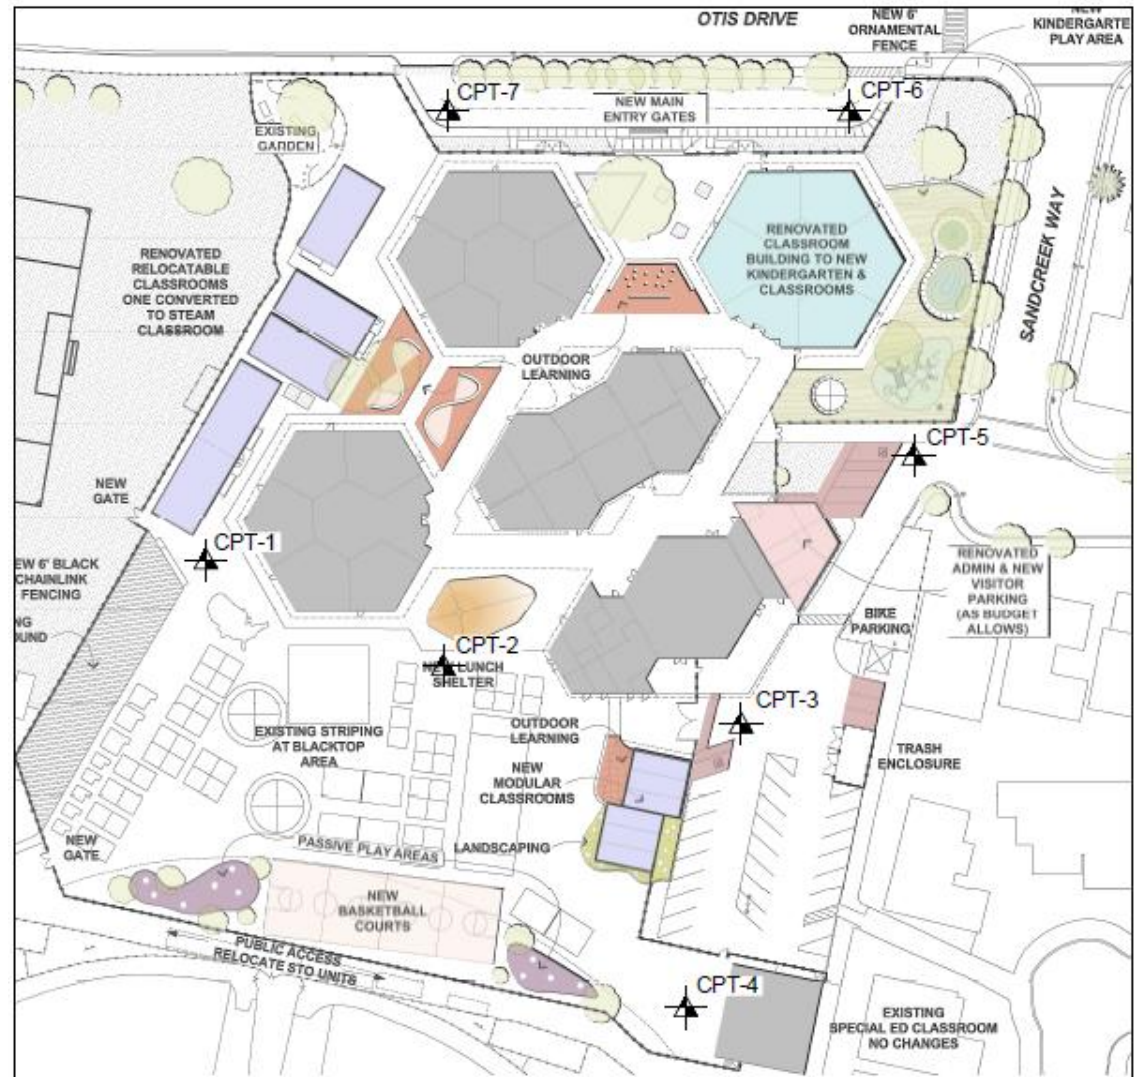
- Tests at the school site indicate that the soil would be subject to liquefaction during a strong earthquake
- Soils tests were taken at various points and showed the same condition across the site

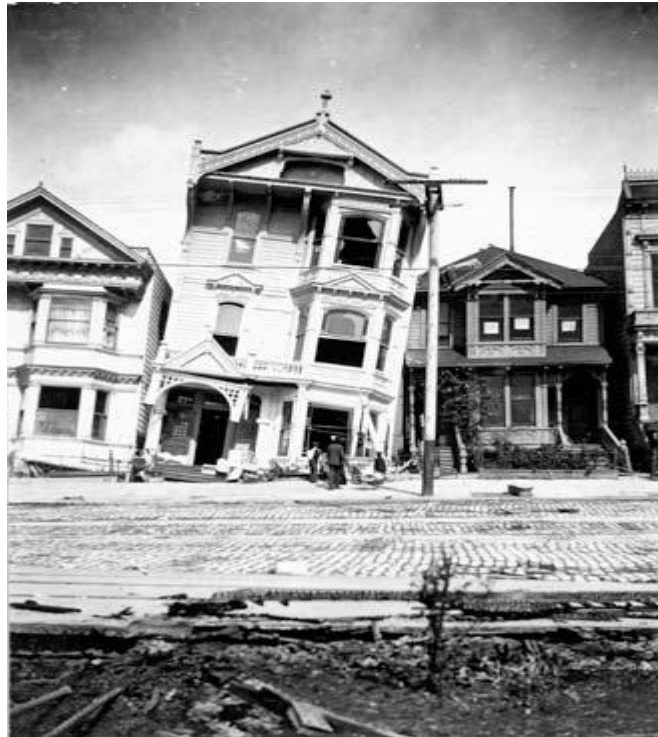
This building is experiencing differential settlement. This type of settlement increases the likelihood of partial collapse.

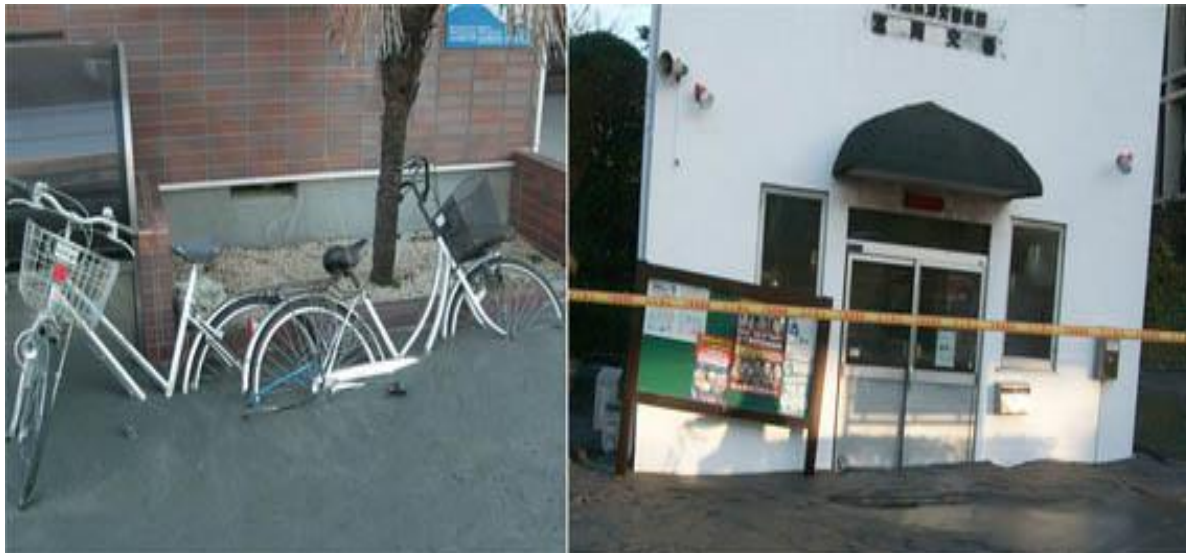
This building is experiencing uniform settlement but the use of the doors has been inhibited.

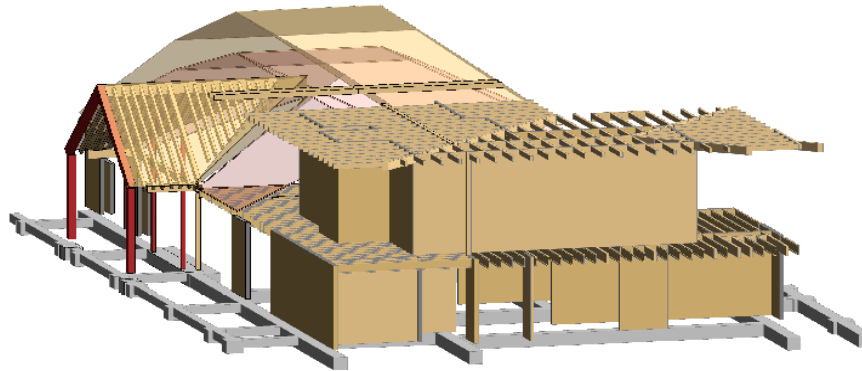
This building has a conventional footing system similar to Lum Elementary which is not designed to accommodate the expected settlement.

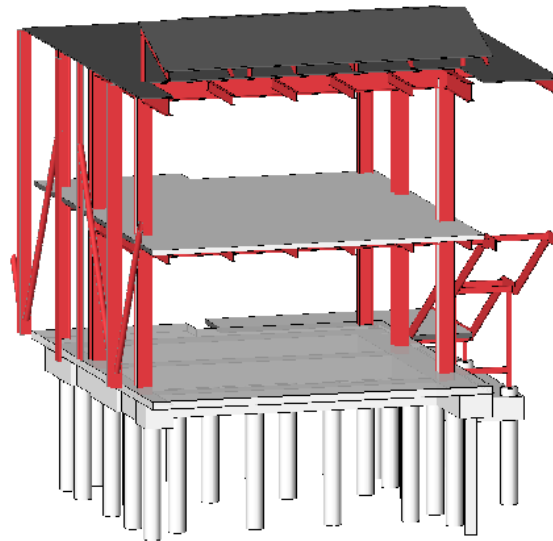
This building has a pier foundation which would extend through the soil which could liquefy.
