Donald Lum Elementary School

DONALD D. LUM ES
4/30/2012

Alameda USD Facilities Assessment

Facility Assessment Spreadsheet

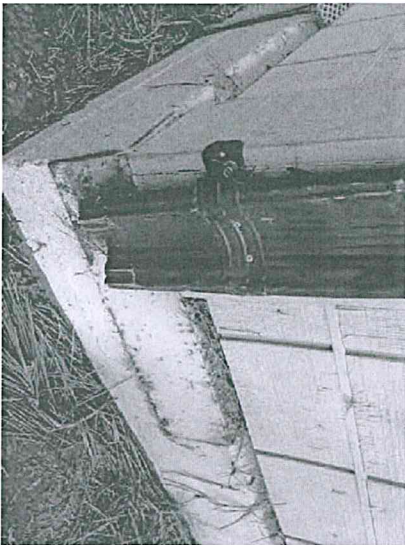
21

9 Existing Deficiency Recommended Remedy	Music Portable: wood panel and foundation dry rot; no site drainage; metal frame and ramp rust; faded paint with different colors. Replace with concrete foundation/ ramp; add site drainage and new RWLs; replace (E) unit with new.	#12, #13, #14, #15	18	CY	\$1,000	\$18,000
10 Existing Deficiency Recommended Remedy	B1 & B2 Portables: gutter down spout missing; no site drainage on west elevation; Replace wood foundation and ramps with concrete; add site drainage and new RWLs; repaint	#10, #17, #18	2,000	SF	\$4	\$8,000
11 Existing Deficiency Recommended Remedy	Day Care Modular: damaged downspout; steel corrosion; ivy growth; wood paneling/trim damage; excess pine tree litter on roof and gutters. Remove all growth from perimeter; add 12" conc. mow strip and site drainage; repair/replace wood panel/trim with cement board and repaint; replace downspouts with RWLs; remove Pines adjacent to roof.	#10, #16, #19, #20, #21	6,400	SF	\$8	\$51,200

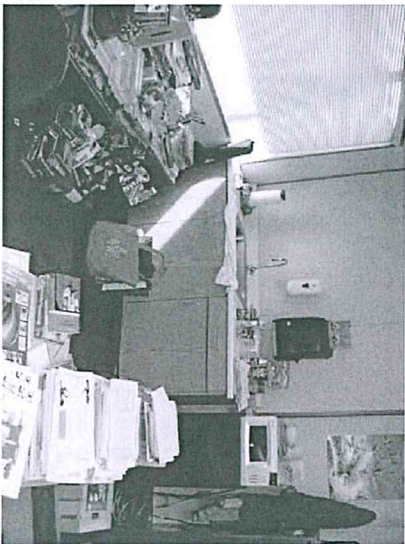
22

i) GENERAL & MAINTENANCE						
1	Existing Deficiency	Deteriorated painted wall and trim finish				
	Recommended Remedy	Repaint all interior walls, trims, doors, and other painted items		36,150	SF	\$2
2	Existing Deficiency	All flooring at end of service life				
	Recommended Remedy	Replace all flooring with resilient flooring, and walk-off Entry carpet mat.		36,150	SF	\$5
3	Existing Deficiency	Multi-Use: applied ceiling tiles delaminating	#27			
	Recommended Remedy	Investigate if roof joists are vented. If not probable dry rot replacement. Install new acoustic ceiling		4,900	SF	\$6
4	Existing Deficiency	Multi-Use Kitchen: does not meet Health Code for Re-heat kitchen	#28, #29			
	Recommended Remedy	Renovate kitchen to District standard for re-heat.; remove Range Hood and gas line stubs		1,800	SF	\$120
5	Existing Deficiency	B3 & B4 Portables: damages ceiling tiles; worn out floor carpet; aged wall paneling, windows, & door	#24, #25

Recommended Remedy	See item #8 above. Provide new modular		1	LS	103000
6	Existing Deficiency	Music Portable: classroom sink is non-accessible; replace ceiling tiles	#22, #26			
	Recommended Remedy	See item #8 above. Provide new modular		1	LS	103000
7	Existing Deficiency	Day Care Modular: damaged ceiling tile from roof leaks	#23			
	Recommended Remedy	Reseal/ repair roof and replace damaged tiles; replace carpet with resilient tile and carpet walk-off entry		1,200	SF	\$12
						\$14,400
