Special Board of Education Meeting Regarding the Condition at Lum Elementary School

RE: Donald Lum Elementary School Liquefaction Settlement

ZFA is providing the following additional commentary, in conjunction with our letter dated April 24, 2017, to clarify our conclusion that the existing classroom, multi-use, and administration buildings at Donald Lum Elementary School have a high potential for partial or global collapse during a design-level seismic event due to foundation failures as a result of expected large differential settlements, and that retrofitting the existing structures is not practical.

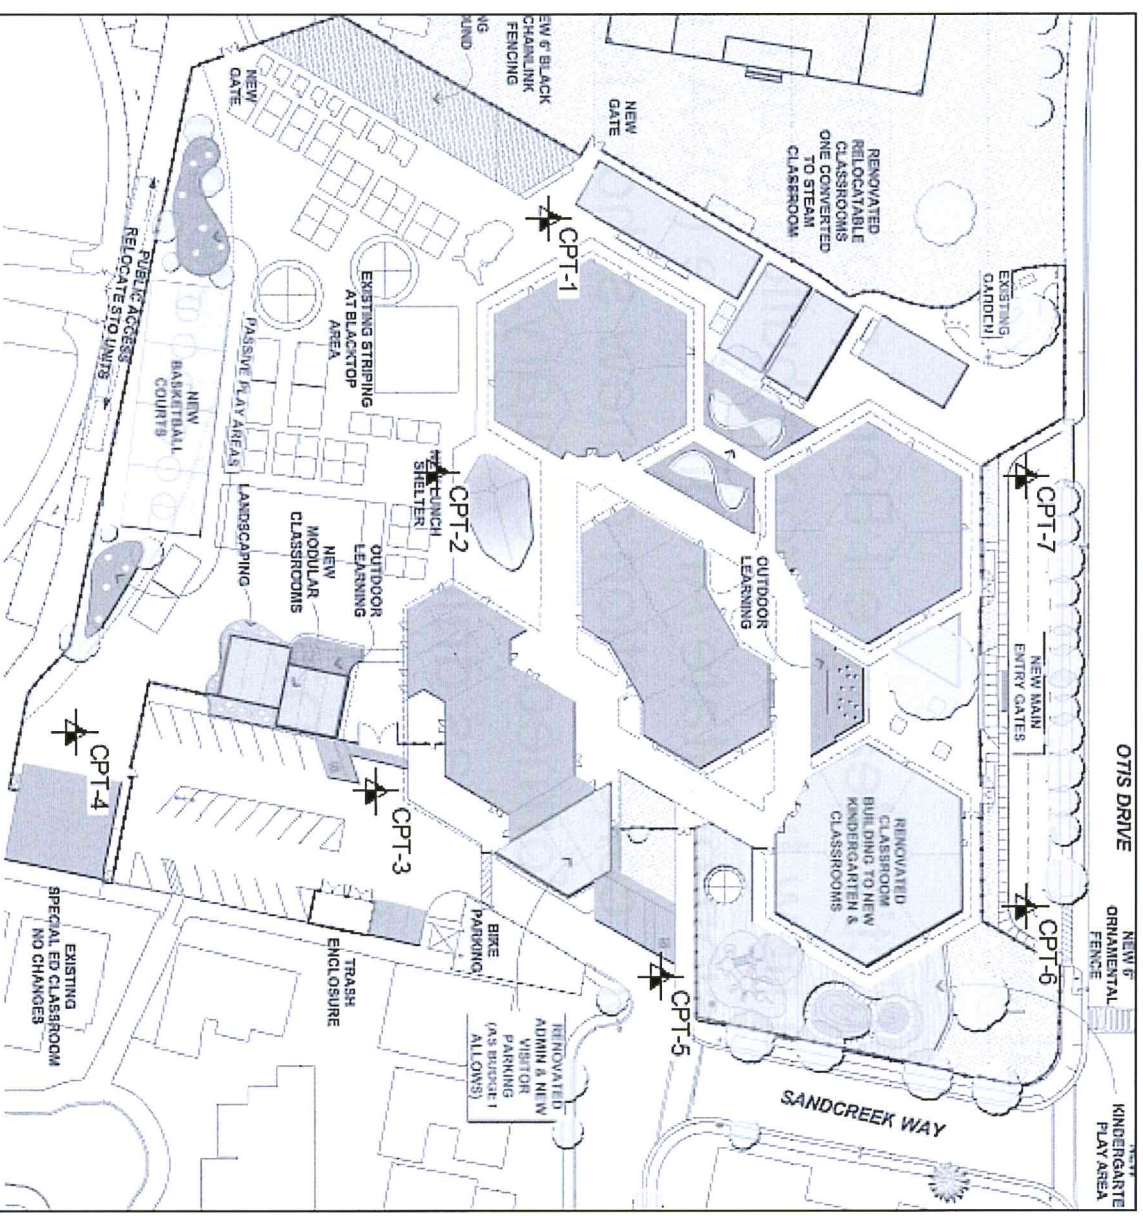
- Tests at the school site indicate that the soil would be subject to liquefaction during a strong earthquake
- Soils tests were taken at various points and showed the same condition across the site

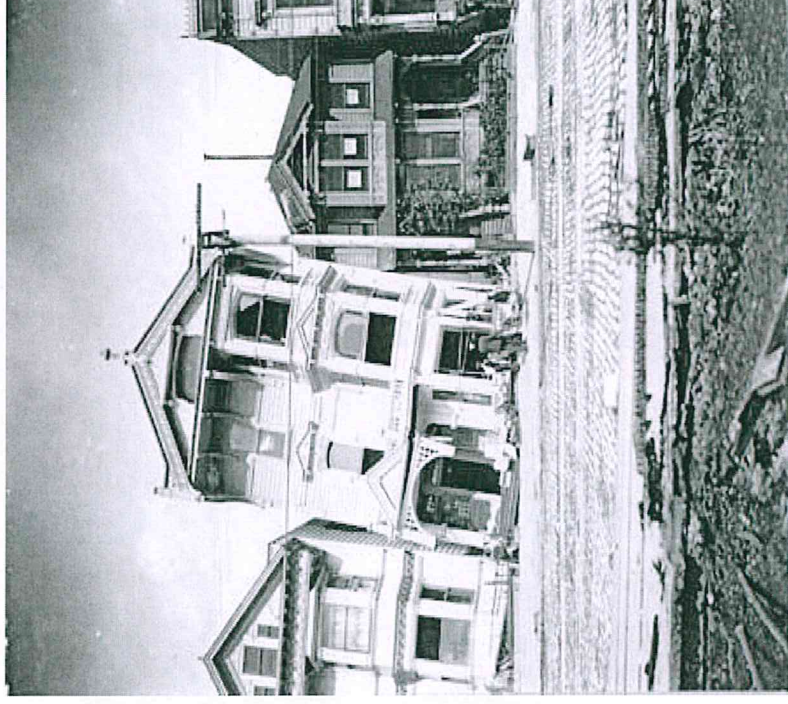
This building is experiencing differential settlement.
This type of settlement increases the likelihood of
partial collapse.

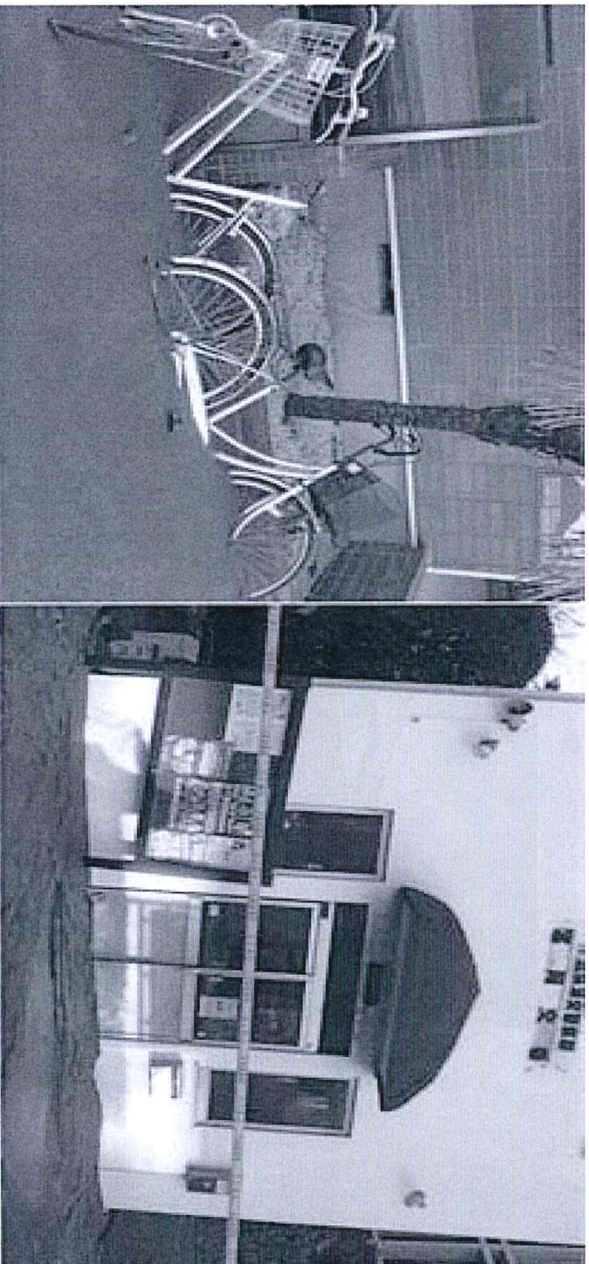
This building is experiencing uniform settlement but the use of the doors has been inhibited.

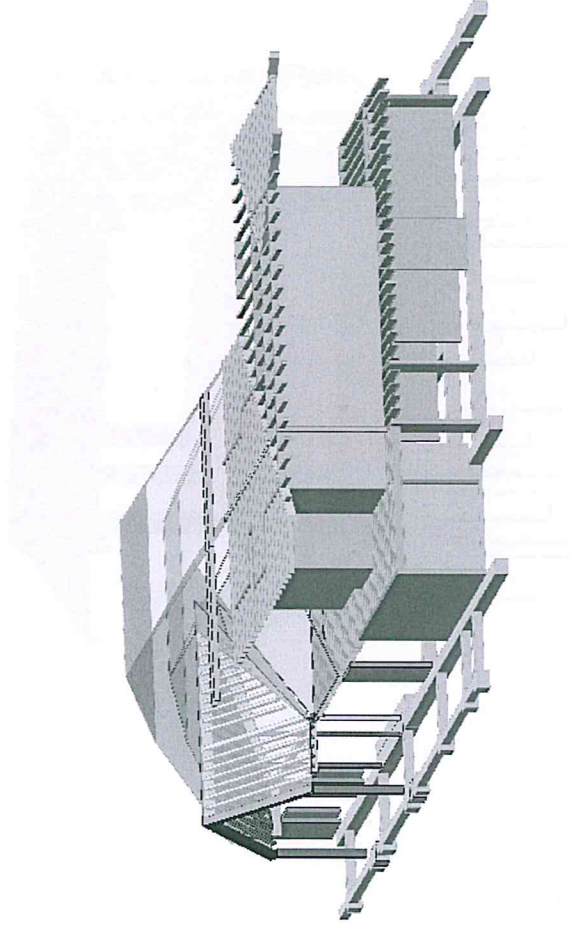
This building has a conventional footing system similar to Lum Elementary which is not designed to accommodate the expected settlement.

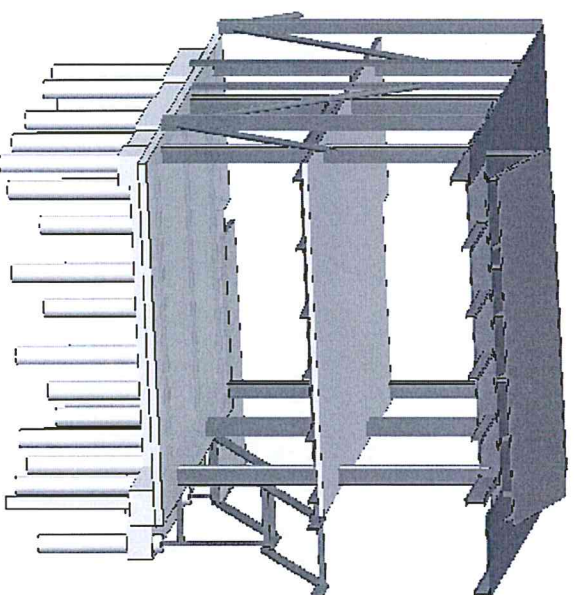
This building has a pier foundation which would extend through the soil which could liquefy.

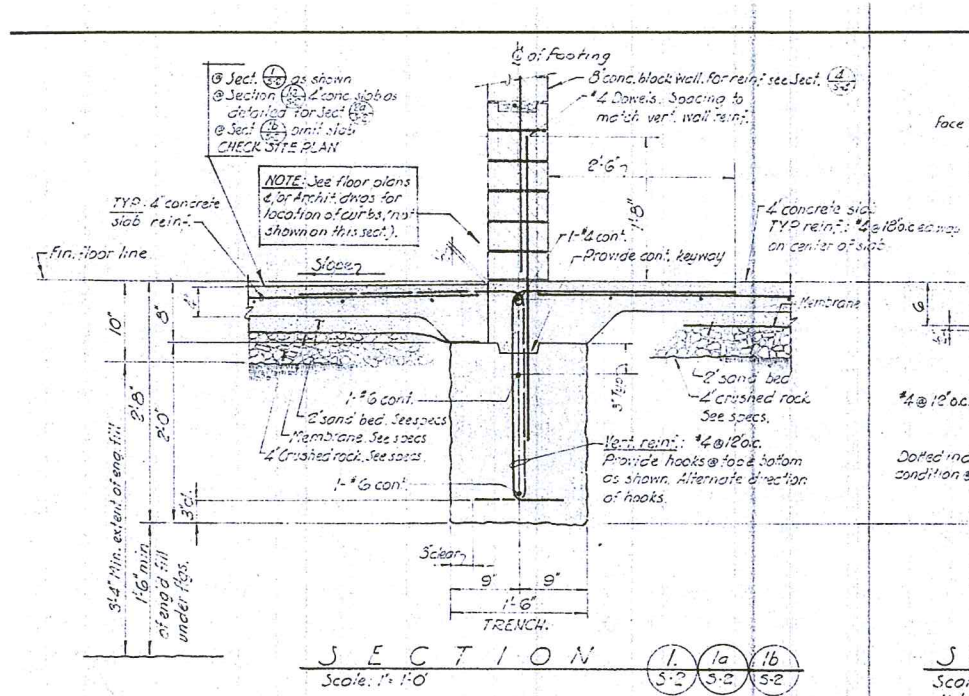
Figure 1 - Existing Footing

The foundations for the earliest buildings, built in 1959-1964, are shallow, relatively narrow footings with a relatively small amount of steel reinforcing. A typical footing section can be seen in Figure 1. In this example, the footing is 24 inches deep and 18 inches wide with one reinforcing bar in the top and another in the bottom of the footing. The later building, built in 1974, is slightly more robust with more footing reinforcement. These footings were designed to support the building weight directly on the soil below. They are not designed for, or adequate to transfer building weight over significant distances to bridge across soil that has lost its strength due to liquefaction. This was, and is, standard practice for building sites with good or average soil conditions. Even modern well designed buildings generally do not have adequate

foundations to withstand the 7" of expected differential settlement expected at Donald Lum Elementary School unless they were specifically designed for it.

We evaluated the existing footings in a couple of typical locations, using ASCE 41-13 Seismic Evaluation and Retrofit of Existing Structures, to span over a length of 25 feet which is similar to other designs of new buildings on liquefiable soil and in conjunction with the Geotechnical Engineer. Based on our analysis, the footings do not have the strength to span this distance and will likely experience displacement matching the liquefaction settlement of the soil below, leading to partial or global collapse of the structure above.
