SEISMIC EVALUATION REPORT

Washington Elementary School 2 Story Classroom Building Alameda, CA 94502

То:	Robbie Lyng
Company Name:	ALAMEDA UNIFIED SCHOOL DISTRICT
Date:	April 2012
Regarding:	Seismic Evaluation of Washington Elementary School 2 Story Classroom Building
Project:	11486.00

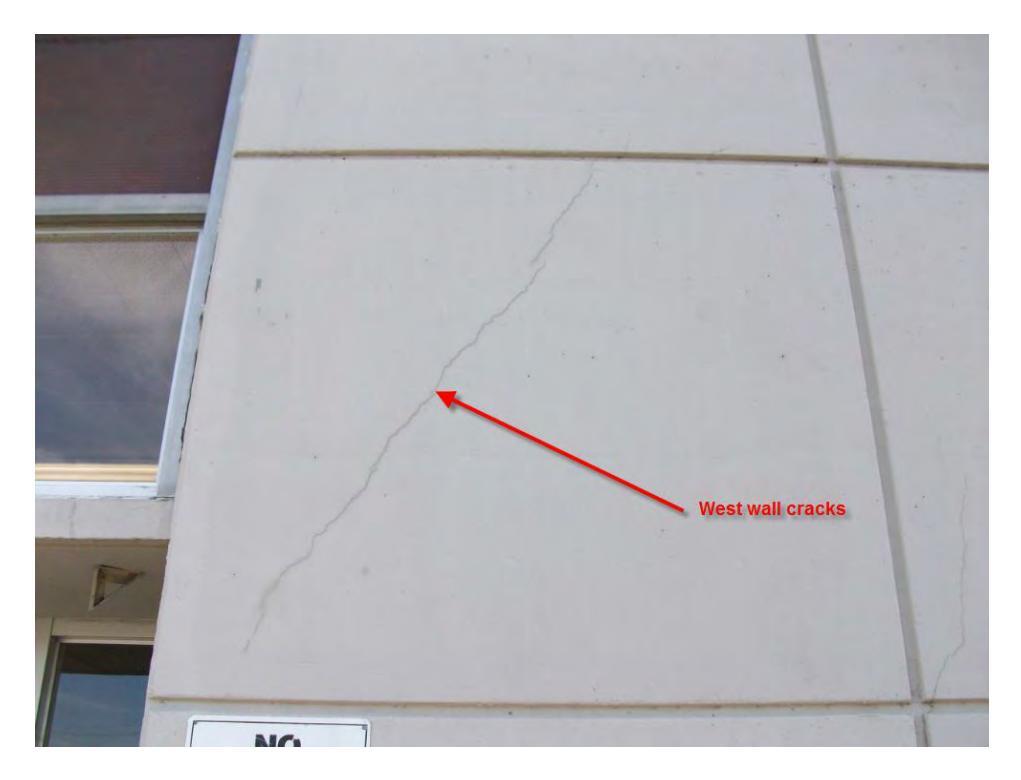
Photo 4: West wall cracks

POST-TENSIONING ANCHORS: There shall be no evidence of corrosion or spalling in the vicinity of post- tensioning or end fittings. Coil anchors shall not have been used. (Tier 2: Sec. 4.3.3.5)	No Post-tensioning anchors
			CONCRETE WALL CRACKS: All existing diagonal cracks in wall elements shall be less than 1/8" for Life Safety and 1/16" for Immediate Occupancy, shall not be concentrated in one location, and shall not form an X pattern. (Tier 2: Sec. 4.3.3.9)	Small cracks were observed at the west exterior concrete wall, however, the cracks appear to be less than 1/8" in width. See photo 4 in App A.

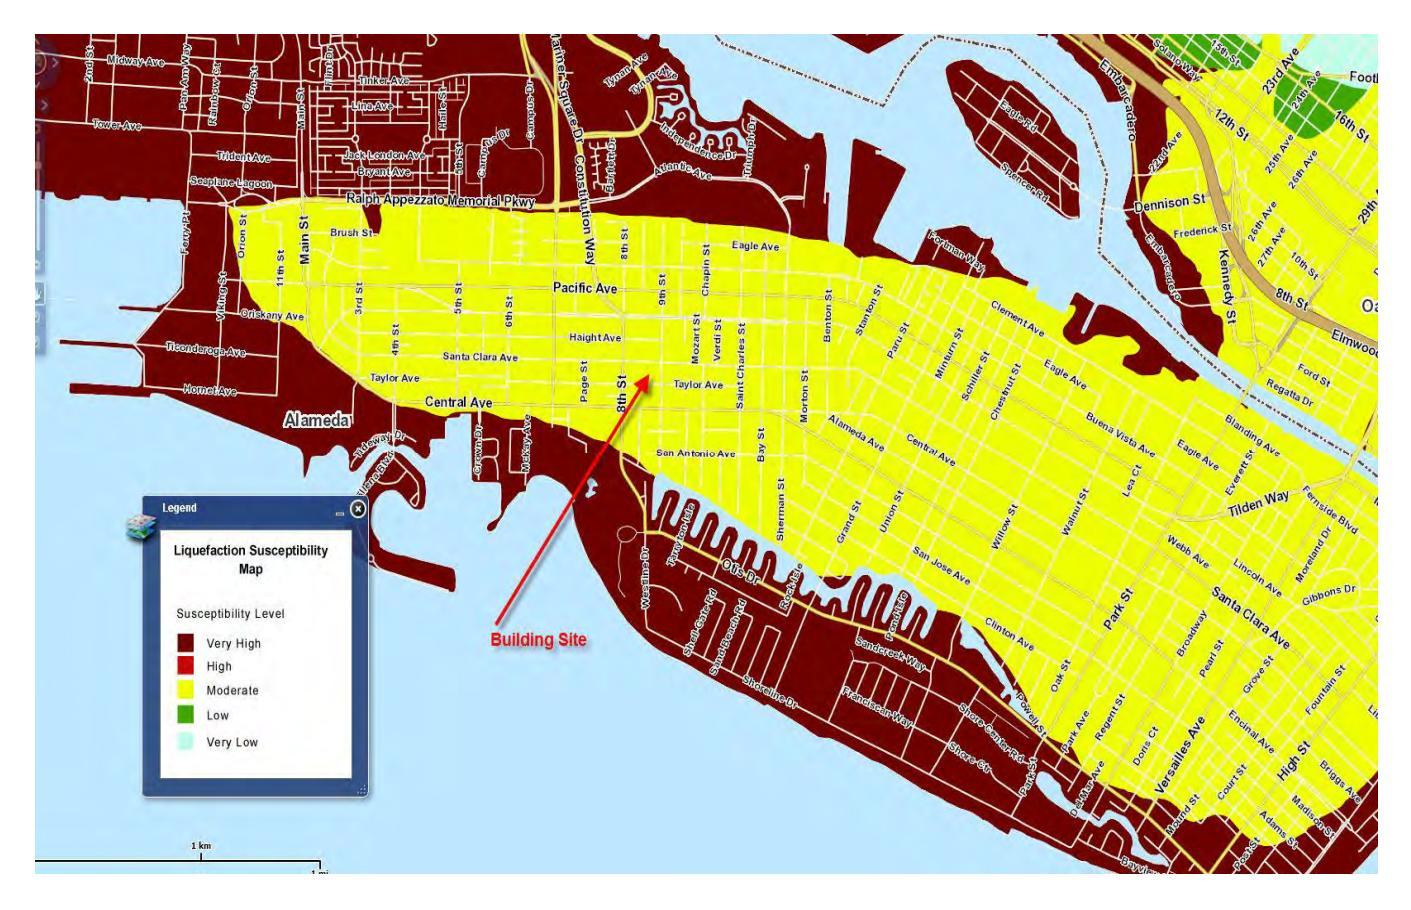
Liquefaction Susceptibility Map

D. GEOLOGIC SITE HAZARDS – LIQUEFACTION (ASCE Section 4.7.1.1) – "Liquefaction-susceptible, saturated, loose granular soils that could jeopardize the building's seismic performance shall not exist in the foundation soils at depths within 50 feet under the building for Life Safety and Immediate Occupancy." Although a soils report and geologic analysis for this site were not available, a liquefaction hazard study of the San Francisco Bay Area, published by the Association of Bay Area Governments (ABAG) does provide some indication of the liquefaction hazard map indicates the structure to be in an area of moderate liquefaction hazard (see Liquefaction Map in Appendix B).

RECOMMENDATION: Site specific geotechnical data would be entirely more accurate for determining if the site complies with Tier 1 criteria. Therefore, a comprehensive geotechnical investigation is recommended. The investigation would include exploratory borings to a minimum depth of 50 feet adjacent to the building to determine expected differential settlement of the soil due to seismic event liquefaction. Additional Tier 2 analysis may be required should the Tier 1 criterion not be met. Some significant foundation modifications could be required.
