Lum Elementary School Update on Community Meetings and Next Steps

June 12, 2018

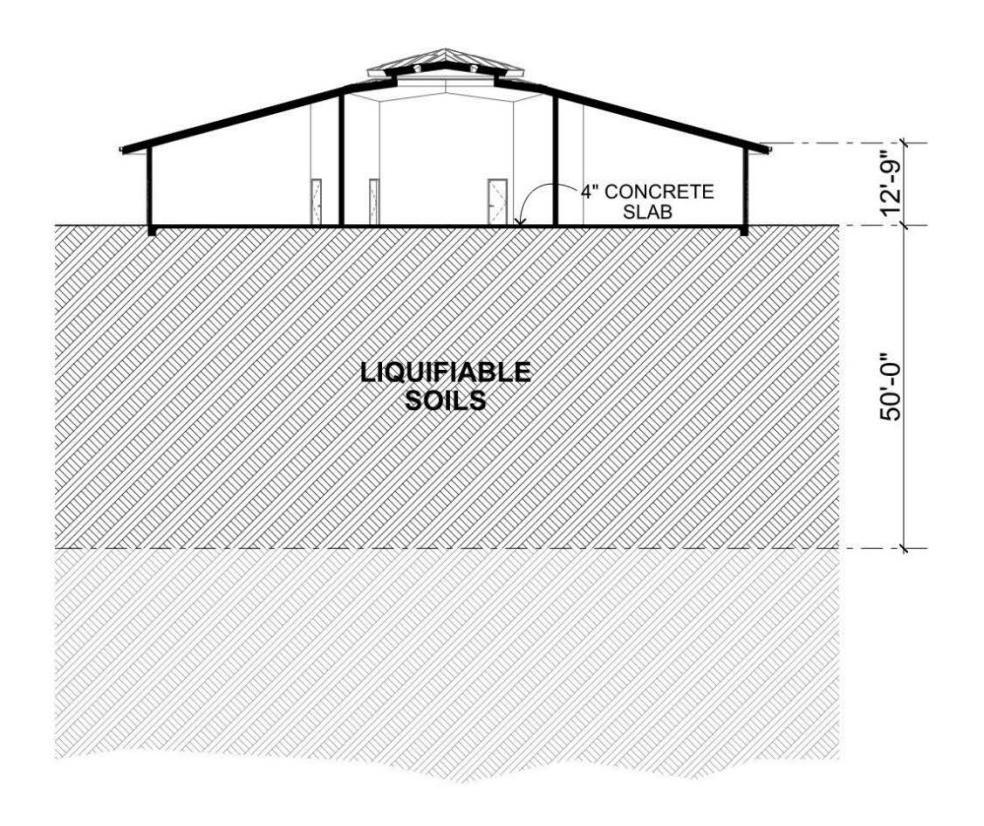
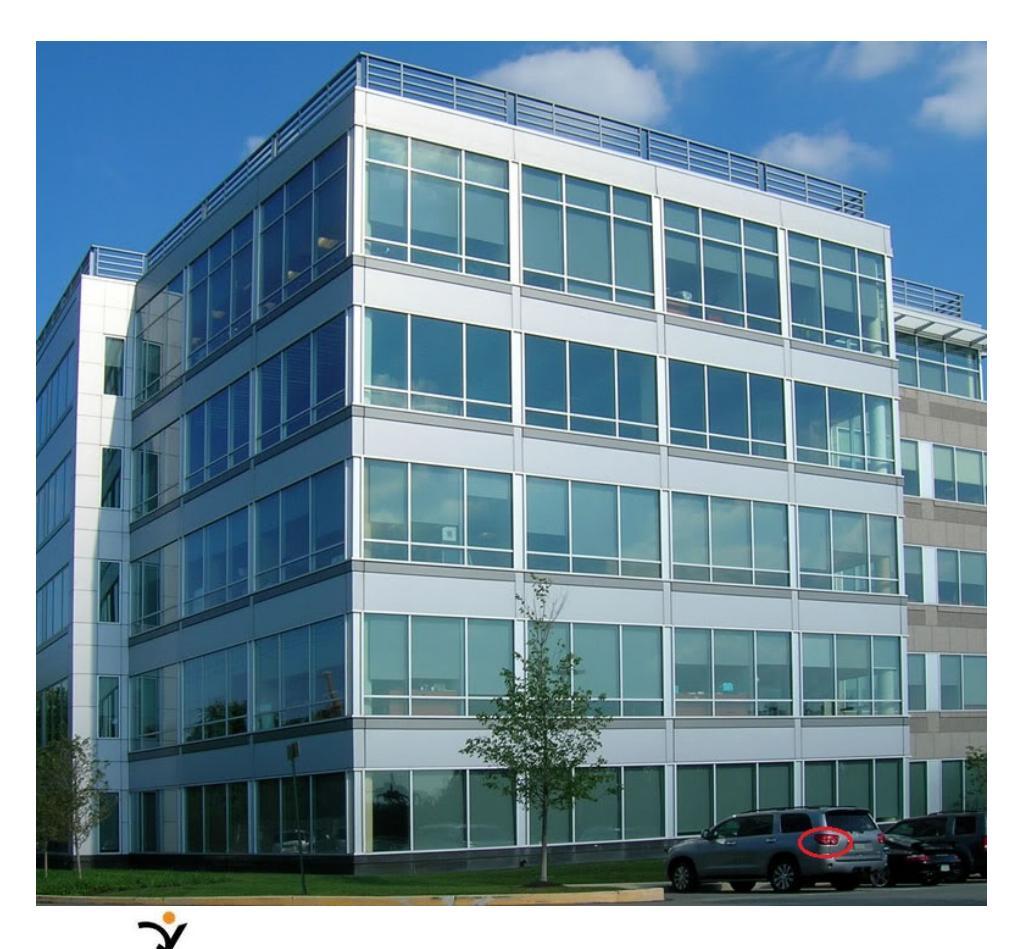
SECTION DIAGRAM DONALD LUM ELEMENTARY SCHOOL

The **soil** beneath Lum's classroom buildings could liquefy to a depth of 50 feet. This could lead to 5 to 10 inches of uneven surface soil settlement in the event of an earthquake.

The **foundations** beneath the classroom buildings at Lum Elementary School are 4 inch slabs of concrete. Geotechnical and structural engineers now know that this type of foundation is not sufficient for structures built on sites with potential for significant soil liquefaction and settlement.

- Significant and invasive work
- o Demolishing portions of roofs, walls, and covered walks, as well as all the slabs
- Driving 90-foot concrete piles into the ground
- Installing new slabs of 8-12 inches thick, plus many concrete beams from 48"x32" to 18"x32"
- Installing new covered walks, wall and roof framing, mechanical and electrical systems, site paving, building finishes
- Significant fire/life safety and accessibility upgrades are also triggered
