Special Board of Education Meeting Regarding the Condition at Lum Elementary School

RE: Donald Lum Elementary School Liquefaction Settlement

ZFA is providing the following additional commentary, in conjunction with our letter dated April 24, 2017, to clarify our conclusion that the existing classroom, multi-use, and administration buildings at Donald Lum Elementary School have a high potential for partial or global collapse during a design-level seismic event due to foundation failures as a result of expected large differential settlements, and that retrofitting the existing structures is not practical.

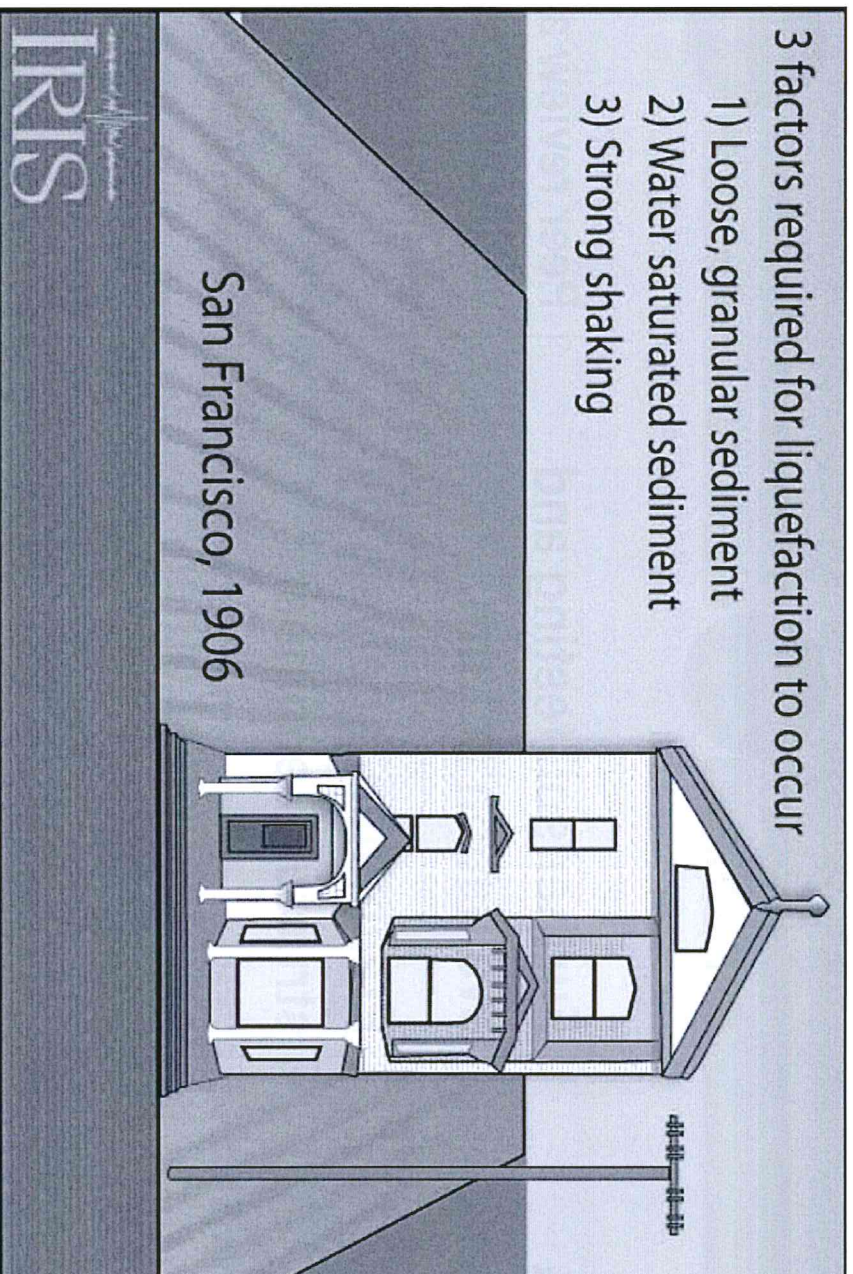
What is Liquefaction?

This building is experiencing differential settlement.
This type of settlement increases the likelihood of
partial collapse.
